Manhole Inspection Summary

Manhole # S39A__049MH

Insp Date: **11/29/07 8:45 AM**

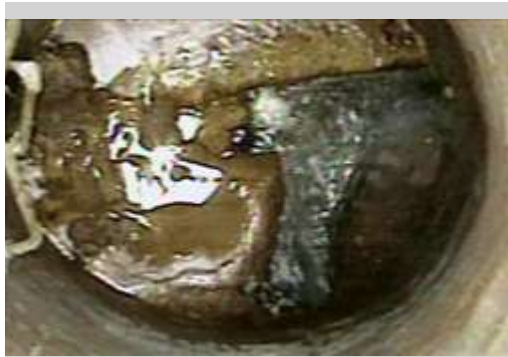
Defect 4

Condition: ☐ Sound ☐ Cracked ☐ Root Intrusion ☐ Deteriorated ☐ Leaks ☒ **Debris**

bench debris

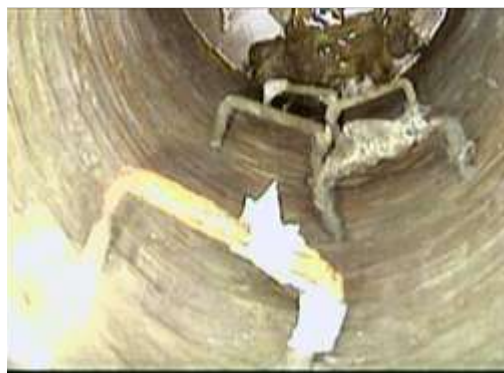
Defect 3

Count: **5** Missing: **0** ☒ **Corroded**

☒ **Evidence Of Surcharge** Depth: **2** (ft.) ☐ Active Surcharge Present

corroded steps, surcharge evidence

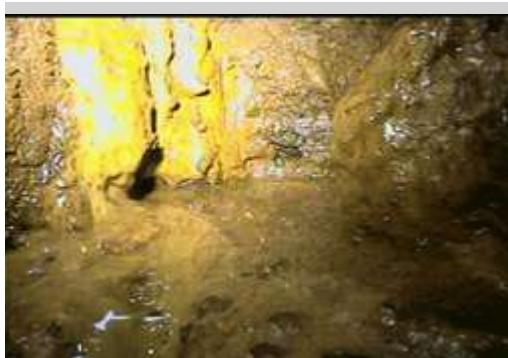
Defect 1

Condition: ☐ Sound ☐ Cracked ☐ Root Intrusion ☐ Deteriorated ☐ Leaks ☒ **Debris**

channel debris

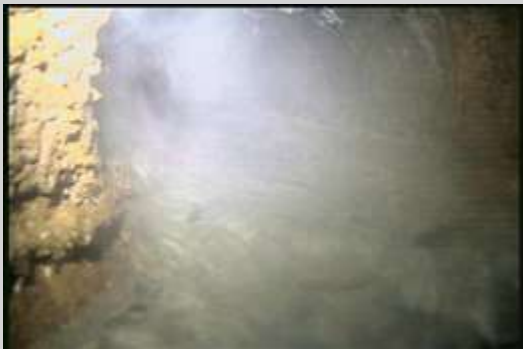
3 O'Clock Inflow

8 in. Circular Gravity Sewer
Pipe In @ 3 O'Clock

Silt Depth: 1 (in.) Deposits Extent: **Light**

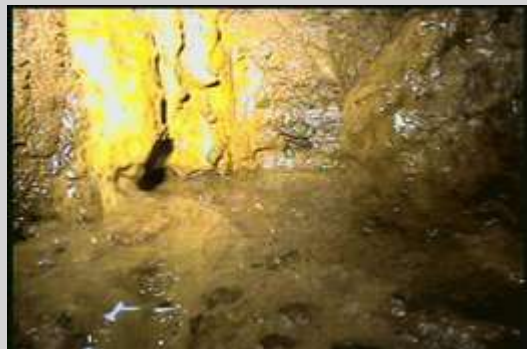
6 O'Clock Inflow

8 in. Circular Gravity Sewer
Pipe In @ 6 OClock

Invert Depth: 9.30 (ft.) Flow Characteristics: None

Deposits: ☐ None ☒ Mud ☒ Sludge ☐ Debris ☐ Grease

Silt Depth: 8 (in.) Deposits Extent: Heavy
